# CONTAMINATION CONTROL IN HYBRID MICROELECTRONIC MODULES

## INTERIM REPORT

JANUARY 1976

HUGHES AIRCRAFT COMPANY  
CULVER CITY, CALIFORNIA

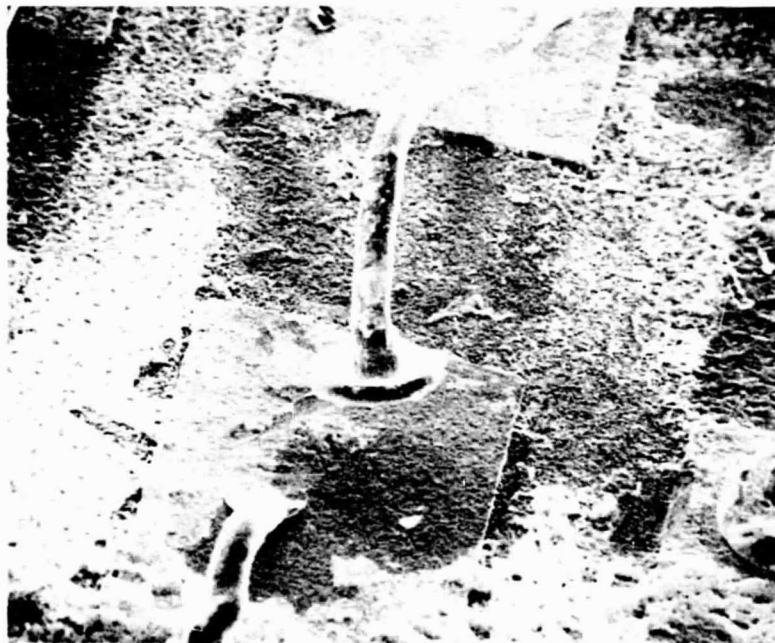
Figure 13. Ultrasonic gold wire bond failure. The ball had lifted from the thin film gold of the plasma cleaned E5 coated part. 200X

In contrast, the majority of thin film bond failures were due to aluminum wire fracture in the necked-down regions, or from the fracture of gold wire. These gold wire failures were primarily characterized by fracture of either the wire near the initial ball bond or the flattened wire of the final bond. Examples of these are shown in Figure 12. However, there were some initial gold wire bonds that lifted from the thin film gold. Figure 13 illustrates this latter condition.
